# Maryland Inventory of Historic Properties <u>Addendum</u>

AA-2177

U.S. Naval Academy Dairy Farm

Gambrills, Maryland

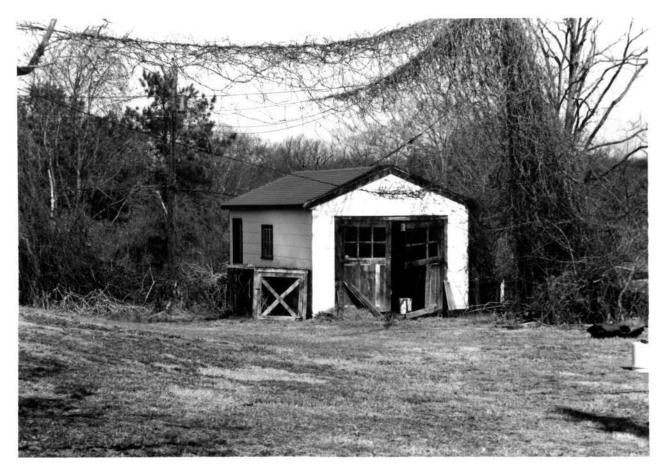
Garage (#171) USNA DAIRY FARM ANNE ARUNDEL COUNTY, MD K. Baynard/ LOWS BERGER GROLEP 3/2007 MHT SOUTH CORNER

The wood-frame garage (Building 171), constructed in 1953, is one story and one bay wide capped with a front-gable, asphalt-shingle roof with a boxed cornice. Set on a concrete foundation, the garage is clad with asbestos shingles and contains double-leaf, panel-and-light wood garage doors. A single-leaf wood door provides pedestrian access on the side elevation facing the dwelling. This southwest elevation also contains a six-light metal awning window.

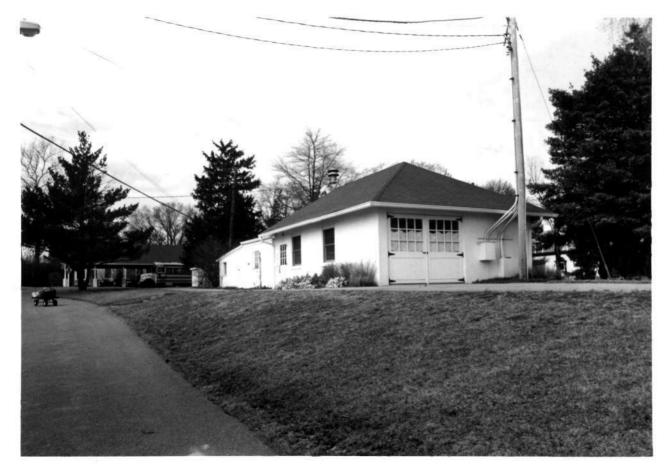
4-2177 FIRE STATION (#Z) USNA DAIRY FARM ANNE ARUNDEL COUNTY, MED K. BAYNARD / LOUIS BERGER GROUP 3/2007 MHT SOUTH CORNER, VIEW LOOKING NEW

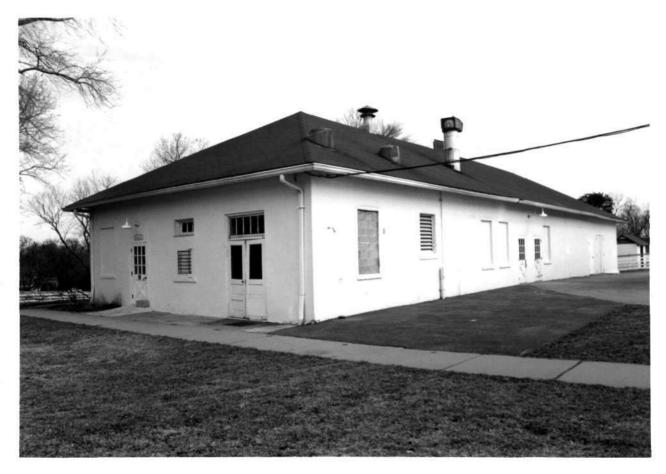
The fire building has replacement vinyl windows.

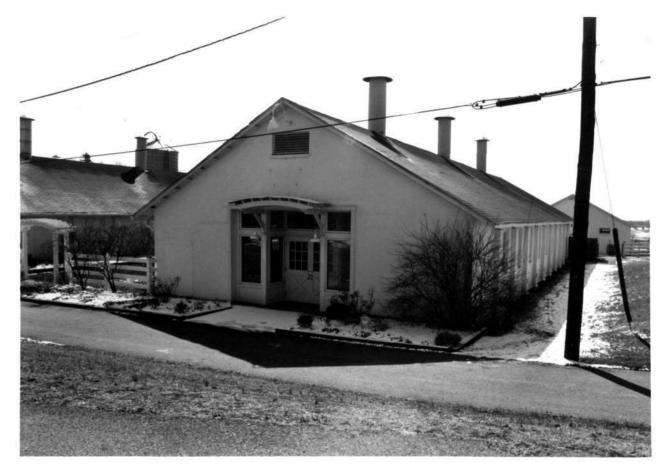
AA. 2177 BARN (432) USNA DAIRY FARM

K. Baynard / Louis BERGER GROUP NE ELEVATION, VIEW LOOKING SOUTH

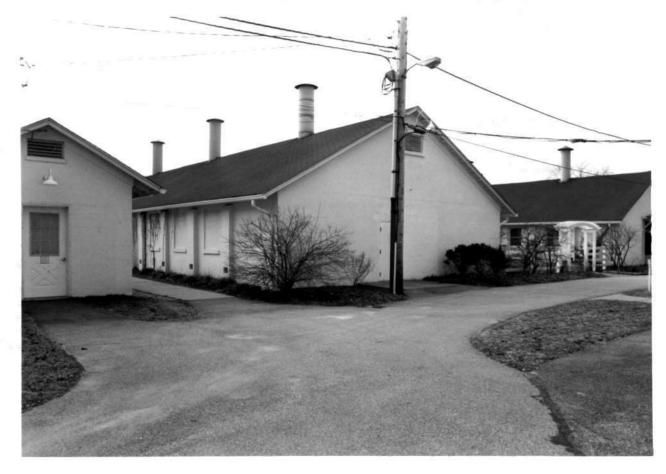
AA. 2177 Cow Barn (#31) USNA DAIRY FARM ANNE ARUNDEL COUNTY. MD K. Baymard/Louis BERGER Group EAST CORNER 10 845

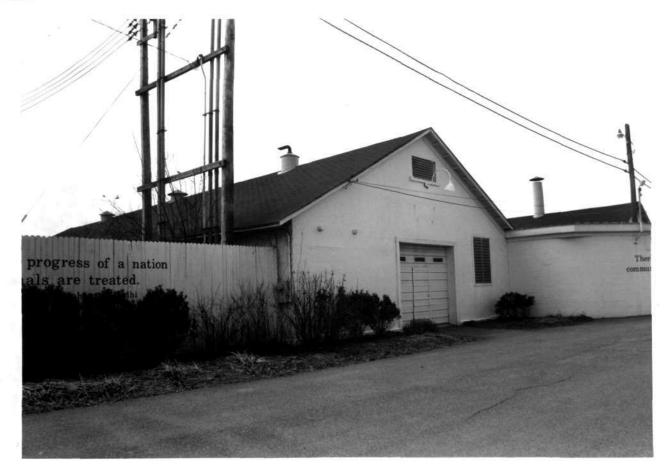
AA- 2177 CON BARN (+29) LISNA DAIRY FARM ANNE ARUNDEL COUNTY, MD K. BAYNARD / LOUIS BERGER GROUP 3/2007 EAST CORNER 12 845

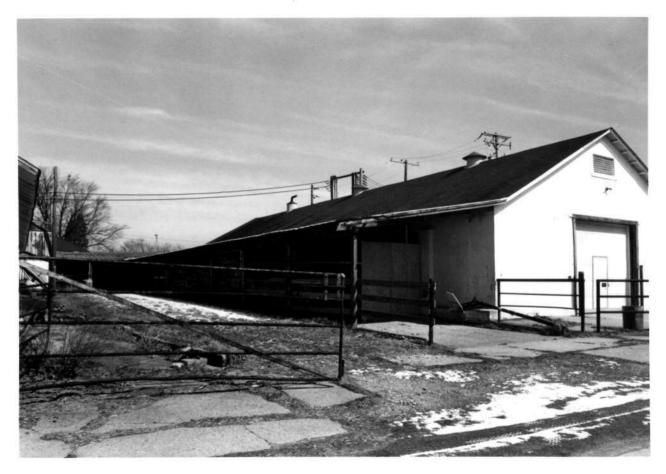
DA-2177 BARN ( 29) USNA DAIRY FARM ANNE ARUNDEL COUNTY, MD K. BAYMARD / LOWIS BERGER GROUP 3/2007 SDUTH & WEST ELEVATIONS, LOOKING NE 13 4 45

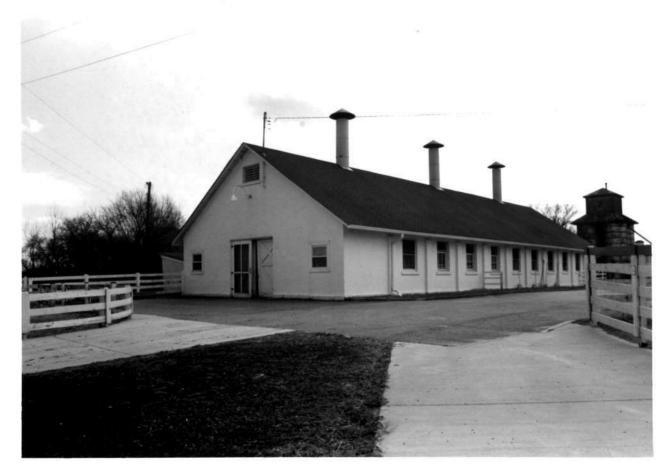
A4-2177 CON BARN (#165) USNA DAIRY FARM ANNE ARUNDEL COUNTY, MD K Bayrard / Louis BERGER GROUP NORTH CORNER 14 of 45

This cow barn is similar in materials, size, and form to the other cow buildings, numbers 28 through 32. It is one story, three bays wide, nine bays deep, and of concrete construction. Set on a concrete foundation, the barn terminates in a front-gable, asphalt-shingle roof. The facade is pierced with two one-over-one, double-hung vinyl windows with square-edged wood surrounds and the gable features a metal louvered vent. Windows in the long elevations are three-light hopper units over fixed three lights, each with a lug-concrete sill. Similar to the neighboring cow barns, engaged pilasters delineate the bays on the

long elevations and three tall metal ventilators are atop the roof ridge. The large rear tractor door has been replaced and sized down to accommodate a single-leaf metal door.

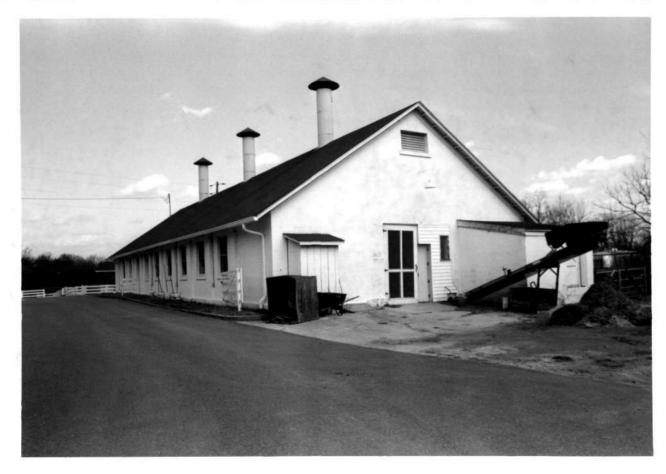
AA-217 COW BARN (#165) LISMA DAIRY FARM ANNE ARUNDEL CXUNTY, MD K Buyard / Louis BERGER GROUP 3/2007 WEST CORNER, (DOKING NE 15 of 45

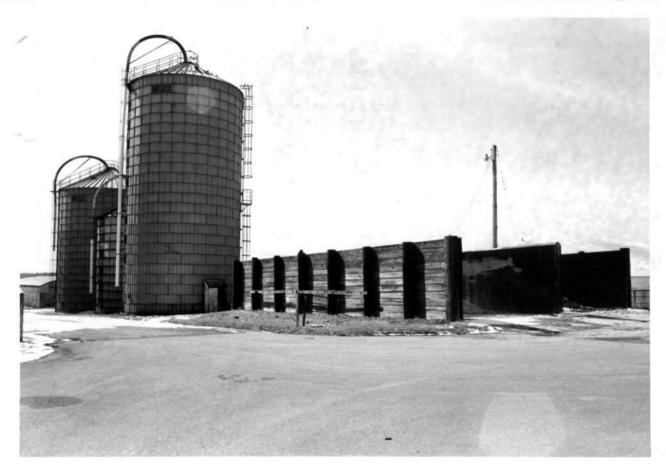
BUNKER SILO (#19), GRAIN TANKS (#6,7,8)

The two ground-level bunker silos are adjacent to one another sharing the center wall. The walls are built of horizontal boards attached to stacked telephone pole sections atop a concrete-slab foundation.

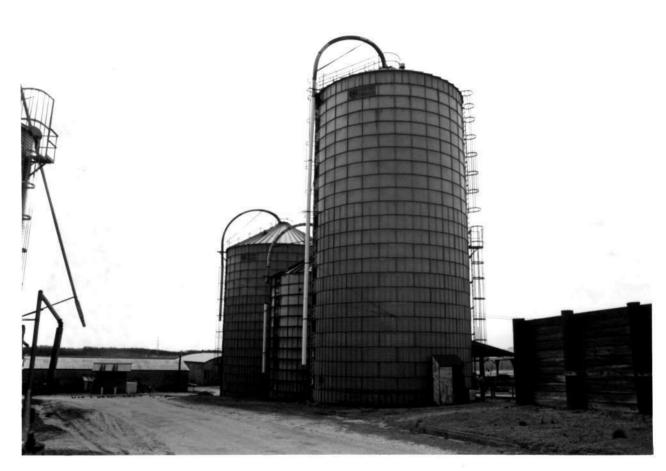
GRAIN TANKS (175, 182, 183)

Manufactured by a company called C&L, the six flat-bottom grain tanks and one hopper tank were erected in various sizes. The tanks have C&L painted on their surface; however, no information was found on this manufacturer. One flat-bottom tank was built in 1965 (Resource 175) and two flat-bottom tanks were erected in 1968 (Resources 182 and 183). Resources 6, 7, 8 are flat-bottom tanks and there is one hopper tank all built after 1996. They are constructed of corrugated steel and capped with conical roofs. The flat-bottom tanks sit on poured-concrete foundations and the hopper tank is supported with steel beams. The small dryer (Resource J) is located between Resource 6 and 7. It sits on steel posts and is used to dry only very small portions of grain.

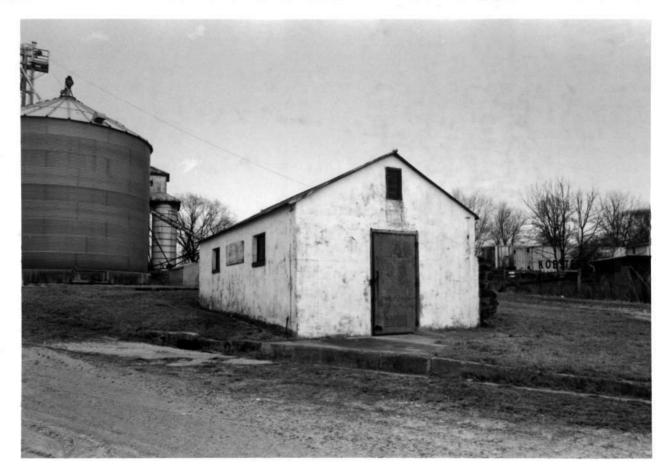
HAZ/FLAMABLE STOREHOUSE (#158)

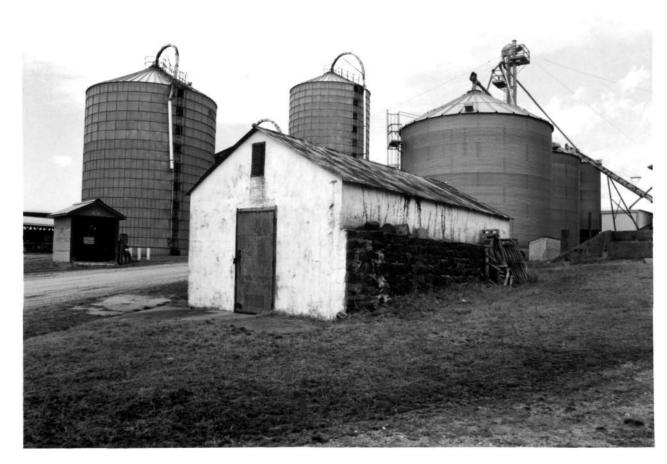
AA-2177 HAZ/F/AMABLE STOREHOUSE (#158) USNA DAVRY FARM ANNE ARUNDEL COUNTY, MD K. BAYNARD/ LOWIS BERGER GROUP 3/2007 MHT SE CORNER

The Hazardous-Flammable Storehouse (fuel storage) was built in August 1948 according to a sign above the door. One story and one bay wide, the building, constructed of concrete, is set on a concrete foundation and terminates in a front-gable roof. A single-leaf metal door punctured with small ventilation holes is centered on the facade. A louvered vent is located in the gable above the door. The west elevation contains two two-light metal awning windows with brick rowlock sills. The roof is sheathed with corrugated-sheet metal and features overhanging eaves. An interesting detail of this building is the rough-edged stone wall that extends from the ground half-way up the wall on the east elevation, possibly foundation remnants of an earlier building.

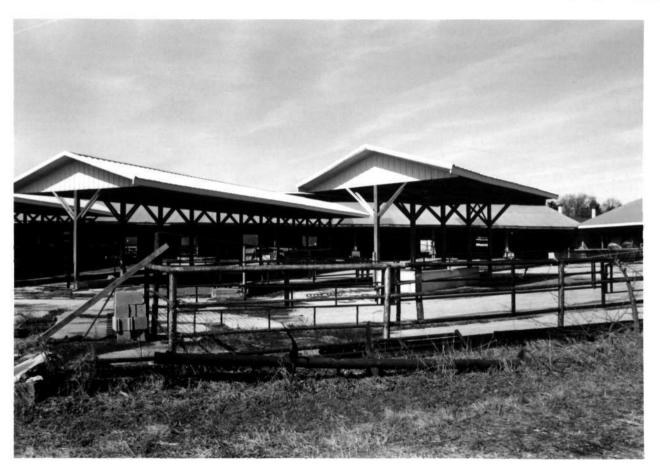
AA-2177 COVERED TROUGHS (\$ 177, 176, 186) USNA DAIRY FARM K. BAYNARD / LOUIS BERGER GROUP 3/2007 SE ELEVATION, VIEW LUDKING NW 34 & 45

Each of the three long concrete troughs are covered with replacement corrugated-metal gable roofs. The 1980 survey indicates they were originally covered with flat roofs.

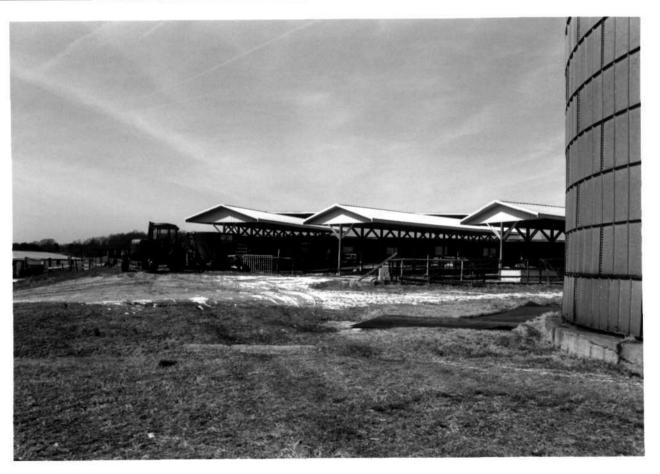
AA-2177 ( OVERED TROUGHS (#176, 177, 178) USNA DAIRY FARM K. BAYNARY LOUIS BERGER GROUP SE ENDS, WEN LOOKING SW 35 08 45

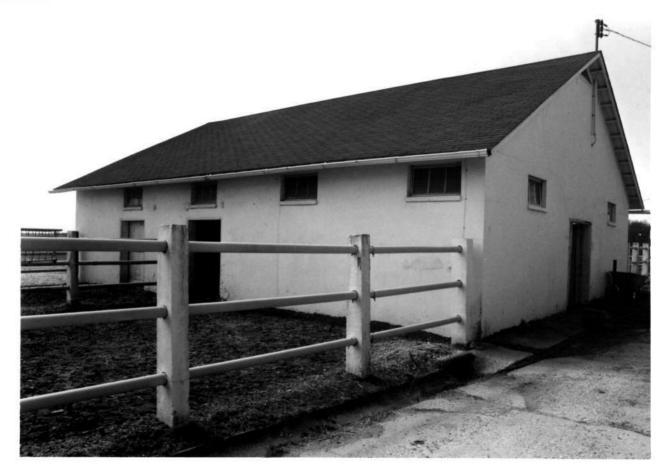
AA-2177
BULL BARN (#164)
USNA DAIRY FARM
ANNE ARUNDEL, MTS
K. Bayrard / Louis Berger Group
3/2007
MHT
NE CORNER

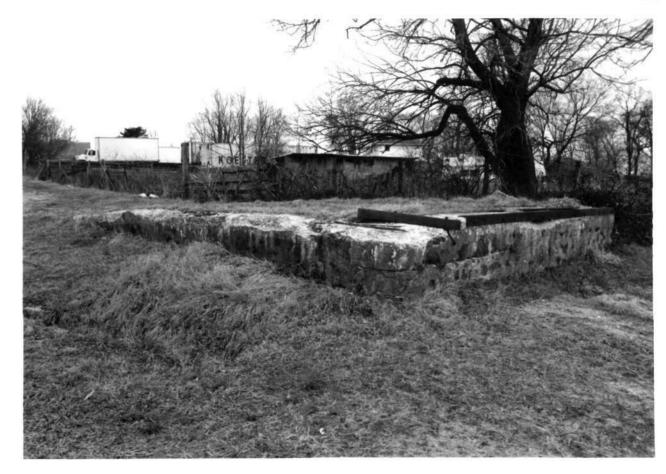
AA-2177 Foundation USNA DAIRY FARM ANNE ARUNDE COUNTY MD K. Baynord / Louis Berger Group 3/2007 MHT VIEW LOOKING NE 38 8 45

Three sets of foundations were located near one another among the dairying resources. Two of the foundations (Resources 10 and A in the inventory) were solid concrete and appear to date to the early twentieth century. The third foundation (Resource B in the inventory) was rough stone parged with concrete.

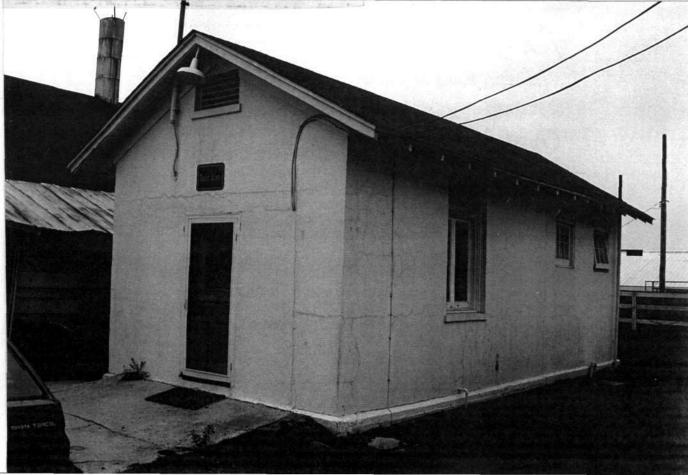
AA-2177 USNA DAIN FARM ANNE ARUNDEL L. CAMPBELL SEPT. 1996 MD SHPO SOUTH, BUILDING 26, FRONT > 1(1) (0) (6) WHINNEY 19AU 6 of 29

<u>Building 26.</u> This simple, one-story, concrete building rests on a concrete foundation. It is one-bay wide and three-bays deep and terminates in a front-gable roof with exposed rafter ends. The frieze consists of beaded clapboards. The front door and selected of windows have been replaced. Original, six-light pivotal windows survive on the east and west elevations. Building 26 was constructed in 1918 as the chemical laboratory, and continues as such.

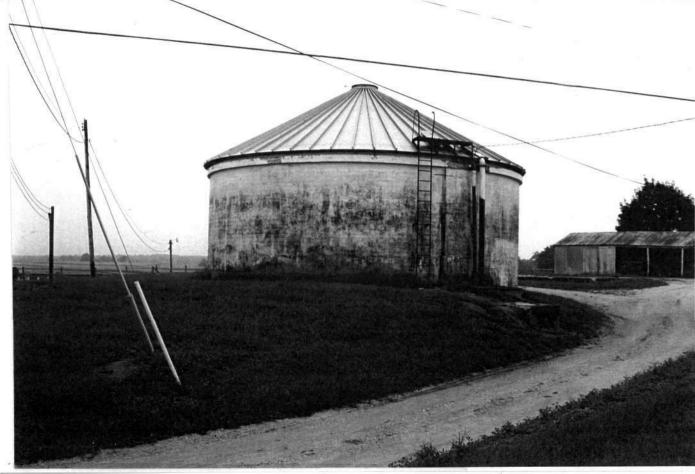
AA-2177 USNA DATRY FARM ANNE ARUNDEL , CAMPBELL SEPT. 1996 SOUTH, BUILDING 38 21 Ct. 82-82 MANAMA 02BG 82X 11 of 29

Building 38. This concrete block water tank rests on a concrete foundation. The tank is 26 ft high, and 36 ft in diameter. It is terminated by a conical roof sheathed with standing seam metal. A metal ladder provides access to an opening in the roof. This water tank was constructed in 1916.

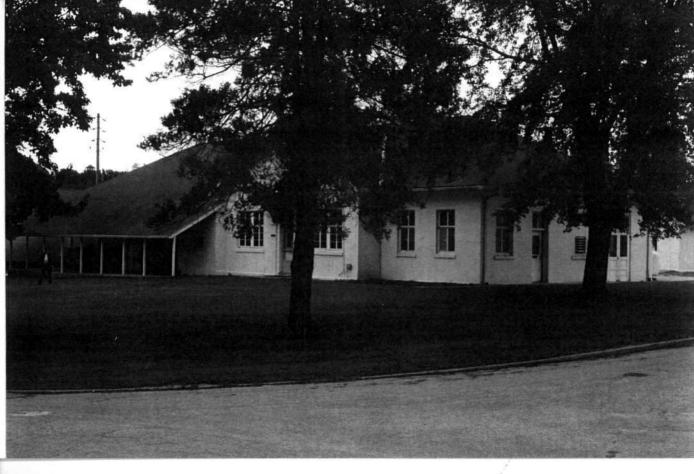
USINA DAIRY FARM ANNE ARUNDEL L. CAMPBELL 1996 MD SHOOTH, BUILDING 25 PHAMMAN ELEVATION 13 of 29

Building 25. Building 25 is a one-story concrete office and cold storage building. It rests on a concrete foundation and terminates in a hipped roof. The north elevation features a cross gable entrance bay which features a bracketed shed hood above the primary entrance, and a small window with diamond-shaped tracery at the peak. All doors are wooden panel and glass units; single doors are surmounted by two-light transoms, and five-light transoms surmount double doors. Each elevation exhibits multi-light casement and pivotal windows with concrete lug sills. The east elevation incorporates a windowless addition to serve as a refrigeration and pasteurization area; the roof at the northeast corner is extended to form a covered loading platform. The west end of the facility houses the offices. A covered walkway at the south elevation leads to Building 172. This building was constructed in 1915 as the Office/Cold Storage Building.

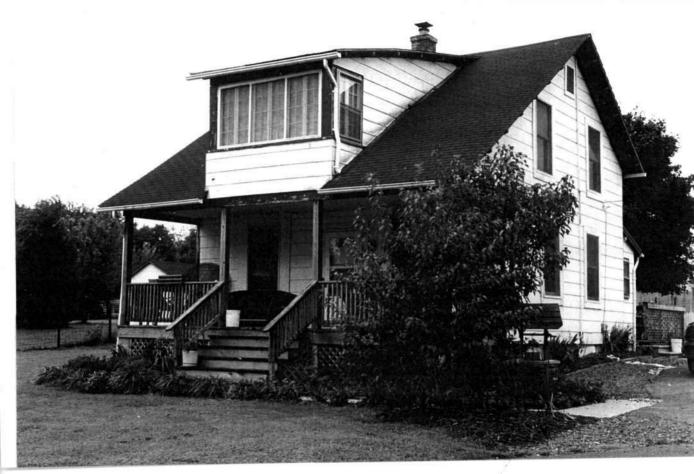
UNITED STATES NAVAL ACADEMY DAIRY ANNE ARUNDEL L. CAMPBELL SEPT. 1996 MD SHPO SOUTH BOILDING 128, FRONT ELEVATION

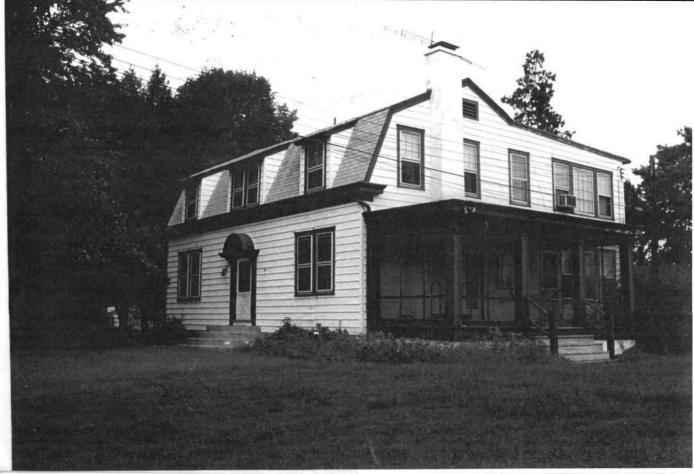
USNA DATRY FARM L. CAMPBELL SEPT. 1996 MD SHO. MUSH10. STOP BESTER HAMMARIZATED BESTER NORTH, BUILDING 101. FRONT + SIDE OF THE 17 of 29

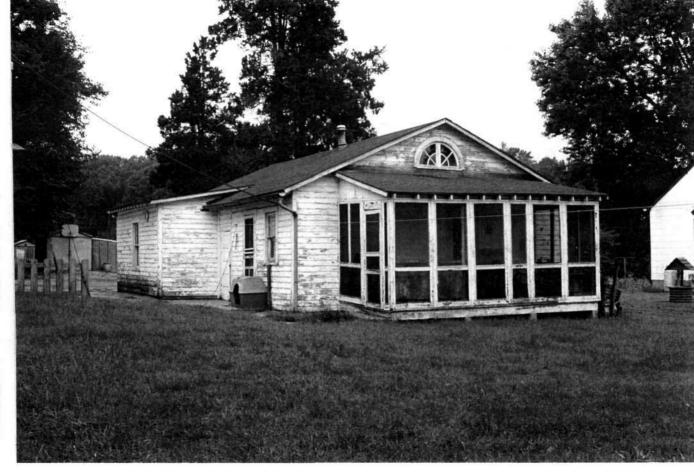
WEST, BUILDING IDIA FRONT AND SIDE

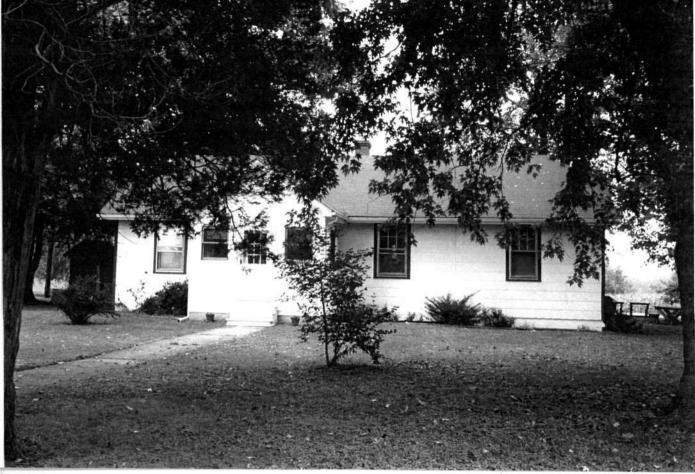
NORTH, BUILDING 1031, FRONTHIN 23AU 1930

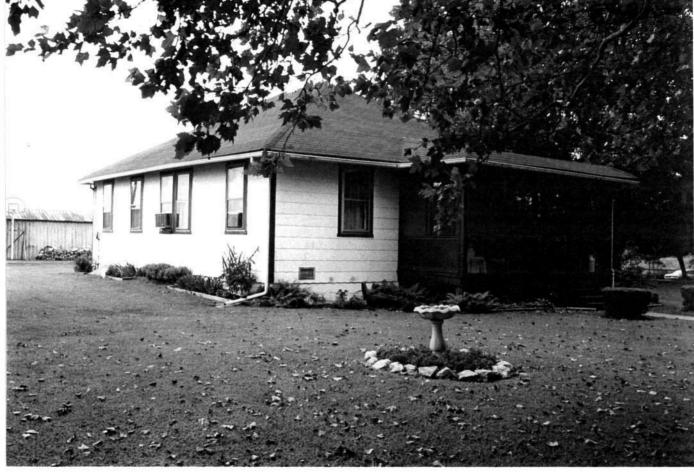
AA-2177 USNA DATRY FARM ANNE ARUNDEL L. CAMPBELL SEPT. 1996 SOUTH, BUILDING 108 FOCNT 20 of 29

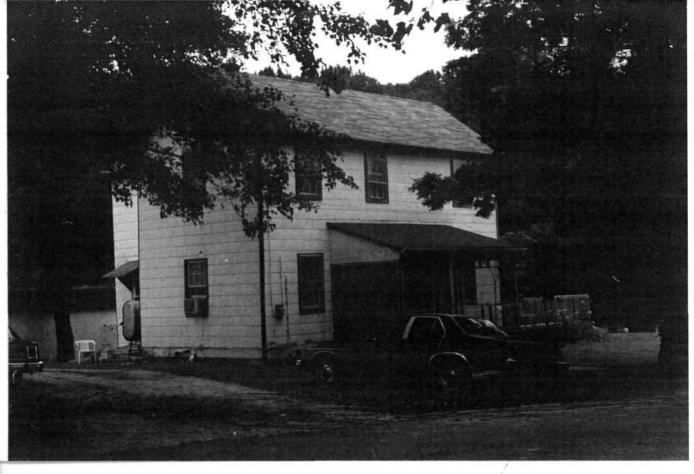
AA-2177 USNA DATAY FARM ANNE ARUNDEL L.CAMPBELL CEPT. 1006 MD SHOO. EAST ELEVATION 21 of 29

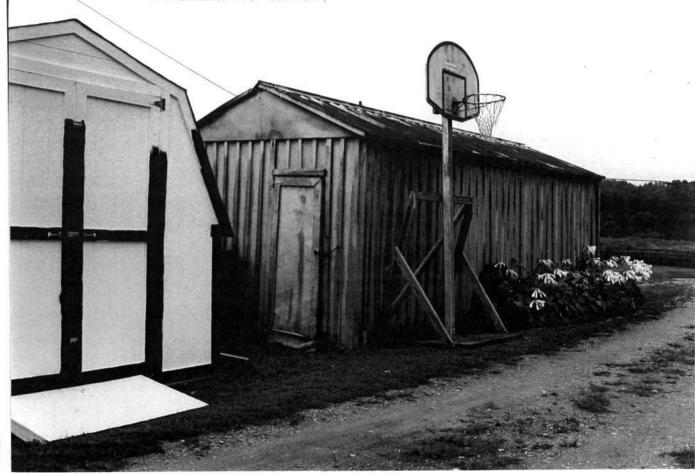
AA-2177 USNA DAIRY FARM ANNE PRUNDEL L. CAMPBELL SEPT. 1996 MD SITTO WEST, BUILDING 190, FROM AND SIDE. SIMF TO 151, 148, 147, 256 EXAMINAN SO SO ADLE . 5 22 of 29

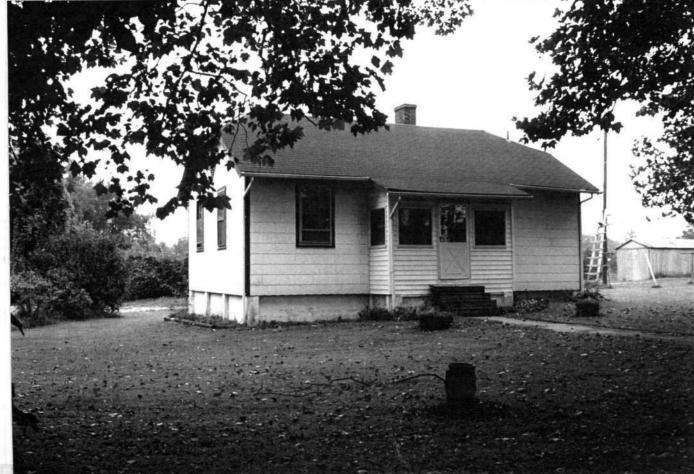
AA-2177
USNA DATRY FARM
AMIL ARUNDEL
L. CANPBELL
GERT. 1996
MID -HBO
POKTH, BUTLOTING 107 FY DAT

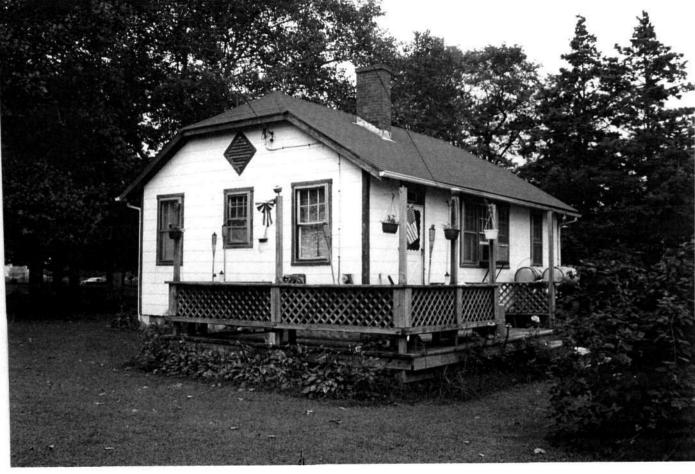
AA-2177 DSNA DALKITARA AMAR HEBBOEL 1. CAMPBELL SCOT. 1996 MD SHPO. EDUTH BUTLING 6 10 1 SIDE AND REAR 24 of 29

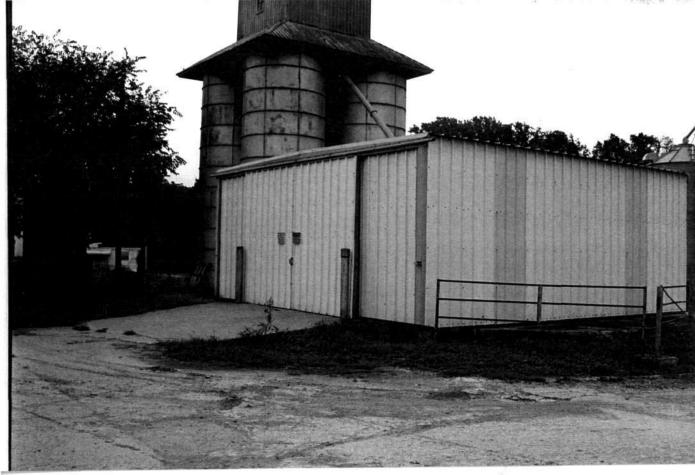
AA-2177 DOSNA DATRUIF ARM FINE AGUNDEL L. CAMPBELL CG7. 1996 MD SHPO SOUTH, BUILDING 11, FRONT AND SIDE 2020 ABO CARAGON AND DO 100 DC 10 27 of 29

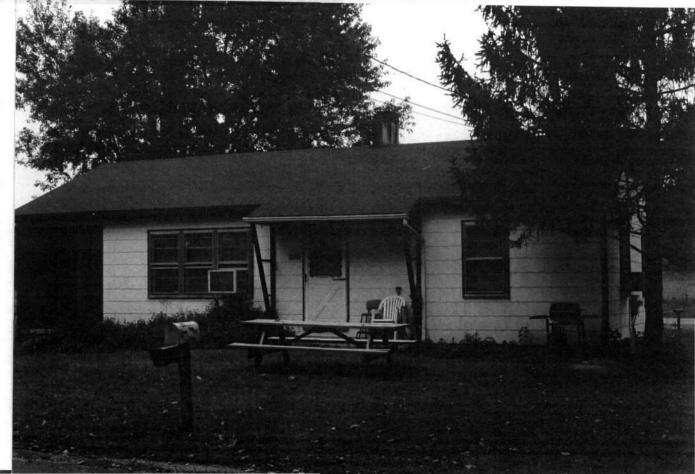
AA-2177 P 1=1-11 SEPT. 1996 MD SHPO ENFLYETON, BUILDIN = 166 28 of 29

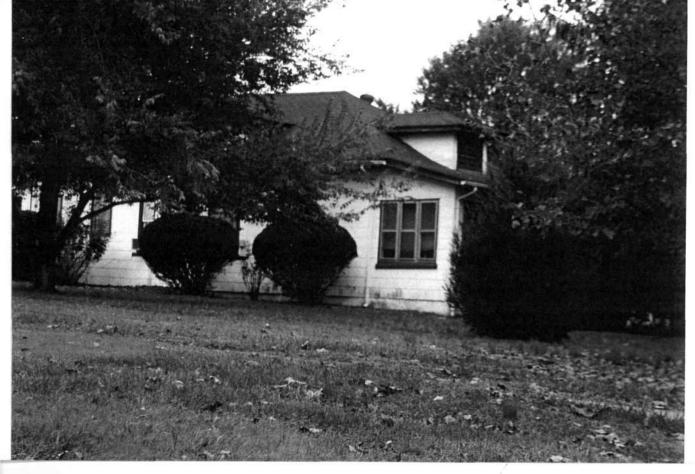
AA-2177 USNA DATRY FARM AMUE AKUNDEL L. CANPBELL SAT 1996 MI SHPO SOUTH, BUZZETING 106, SIDE + FRONT ECECA
